DEPARTMENT OF TRANSPORTATION

Contract #: 04-0120F4Cty: SF/ALA Rte: 80 PM: 13.2/13.9File #: 69.28**WELDING INSPECTION REPORT****Resident Engineer:**Pursell, Gary**Address:** 333 Burma Road**City:** Oakland, CA 94607**Report No:** WIR-015075**Date Inspected:** 20-Jun-2010**Project Name:** SAS Superstructure**OSM Arrival Time:** 700**Prime Contractor:** American Bridge/Fluor Enterprises, a JV**OSM Departure Time:** 1900**Contractor:** Zhenhua Port Machinery Company, Ltd (ZPMC), Changxing Island **Location:** Shanghai, China

Orthotropic Box Girder (OBG) Trial Assembly Areas

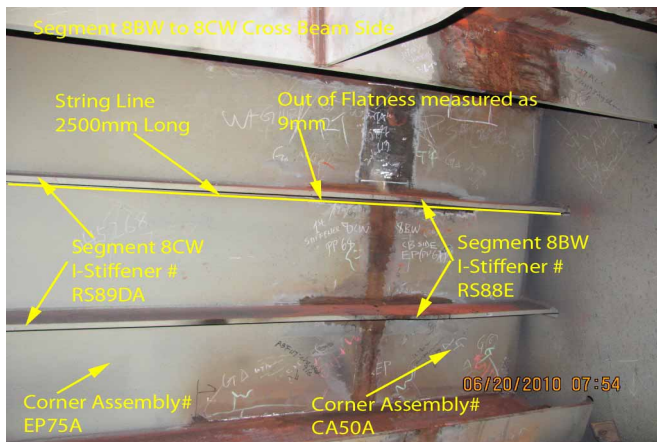
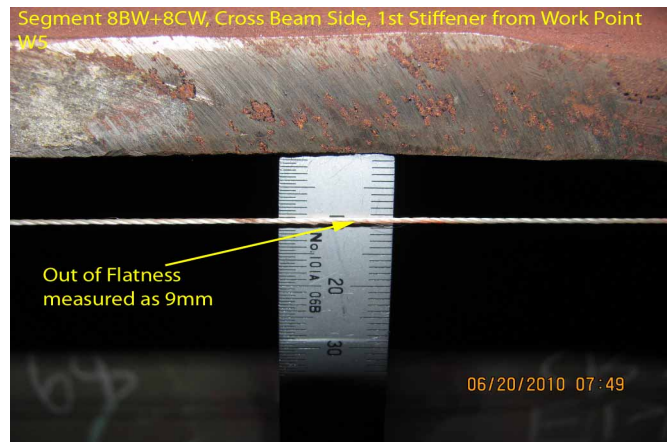
This Quality Assurance (QA) Inspector wrote an Incident Report for Out of Flatness for Horizontal I-Stiffener welded at Corner Assembly at Transverse Splice at Cross Beam and Counter Weight Side for Segment 8AW to 8BW and 8BW to 8CW between Panel Point (PP) 64 to PP 64.5 and PP 67 to 67.5 for more comprehensive details please refer the Incident Report 04-0120F4_TL-15_B278_06-20-10_8BW&8CW_Flatness_Corner Assembly_CB & CW Side Panel Point_PP 67 to PP67.5 Dated June 20, 2010. Please refer the attached pictures for more comprehensive details.
